# Jardy Property Inspections

## Home Inspection Report

P O Box 301, Broomfield, CO 80038  
Inspection prepared for: Report Sample  
Date of Inspection: 5/28/2013 Time: 5:00pm

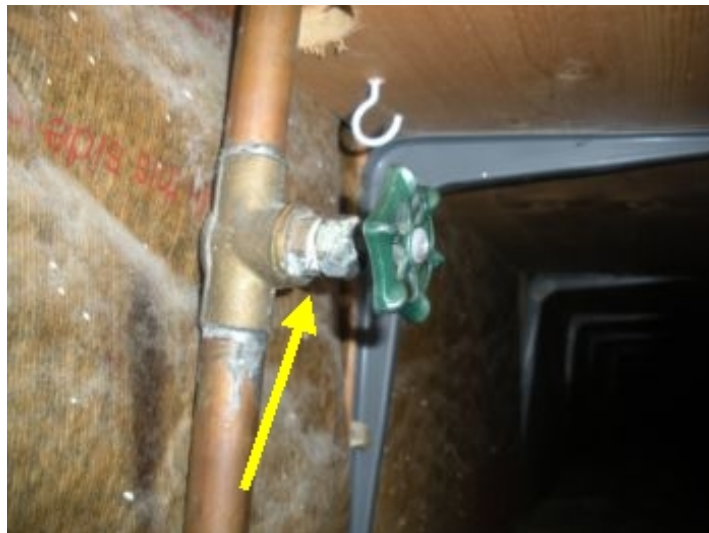
Not Acceptable: The main water line is leaking at the shut off valve.

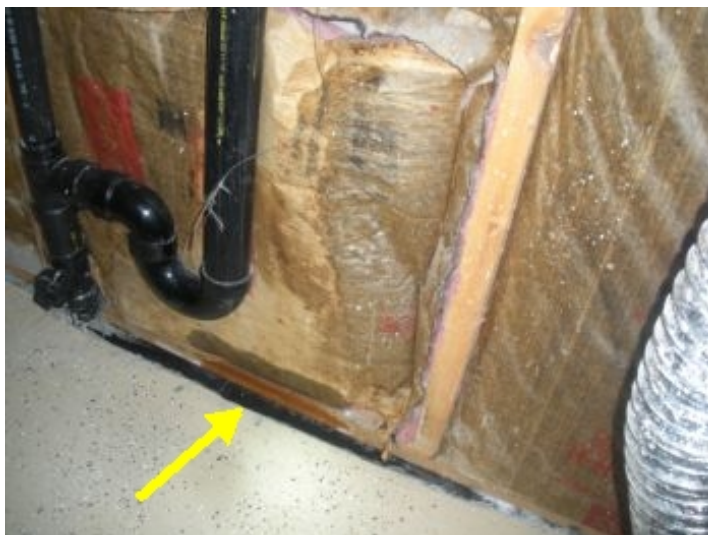
Needs Attention: There is standing water at the laundry area. The source of the water could not be found.

Recommend review by a licensed plumber for repair or replacement, as necessary.

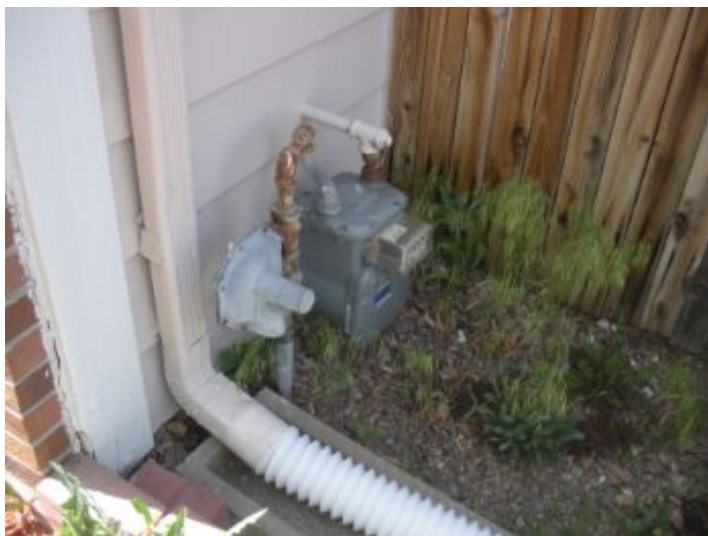
The gas meter is located on the right side of the house

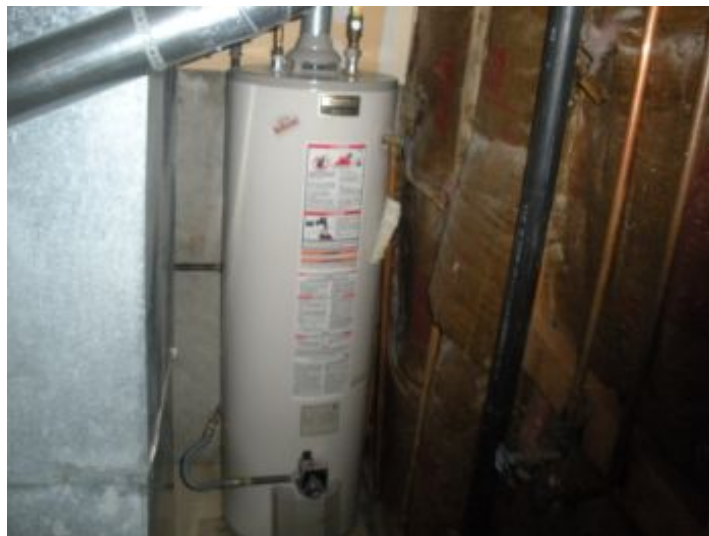
Needs Attention: The water heater is old and nearing the end of its expected life span. It may need to be replaced soon.

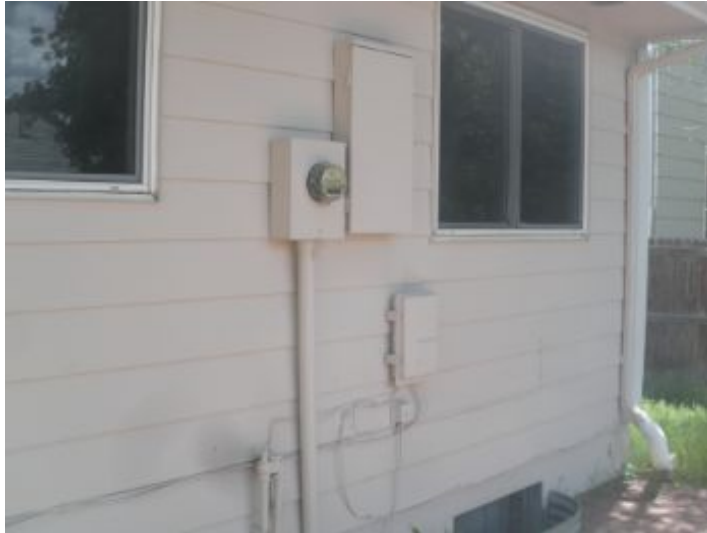
Main Service Drop is underground

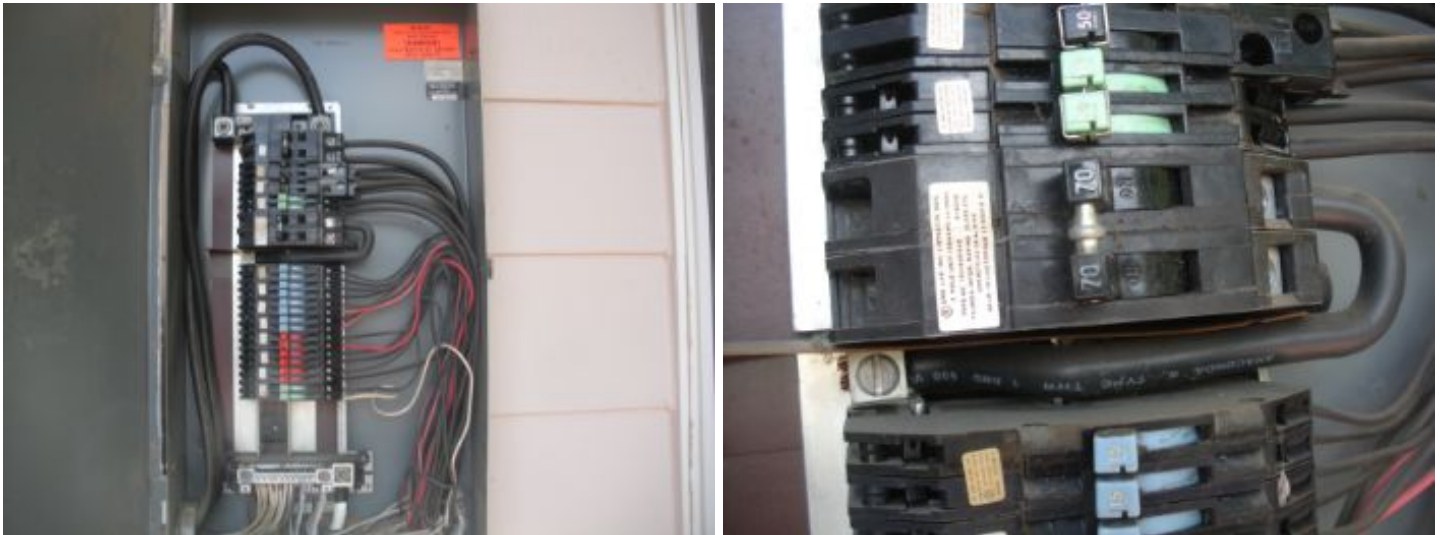
Needs Attention: There is no main breaker seen to shut off all the power to the circuits in the house. This is an important safety requirement for any building with six or more breakers and one needs to be installed.

Needs Attention: This appears to be an alteration from the original, there is a split-bus panel.

Needs Attention: This is an older and limited electrical panel Zinsco/Sylvania. It is more prone to failure due to it's age and design, and repair or replacement parts may be difficult to obtain. An electrician may recommend replacing and upgrading this system.

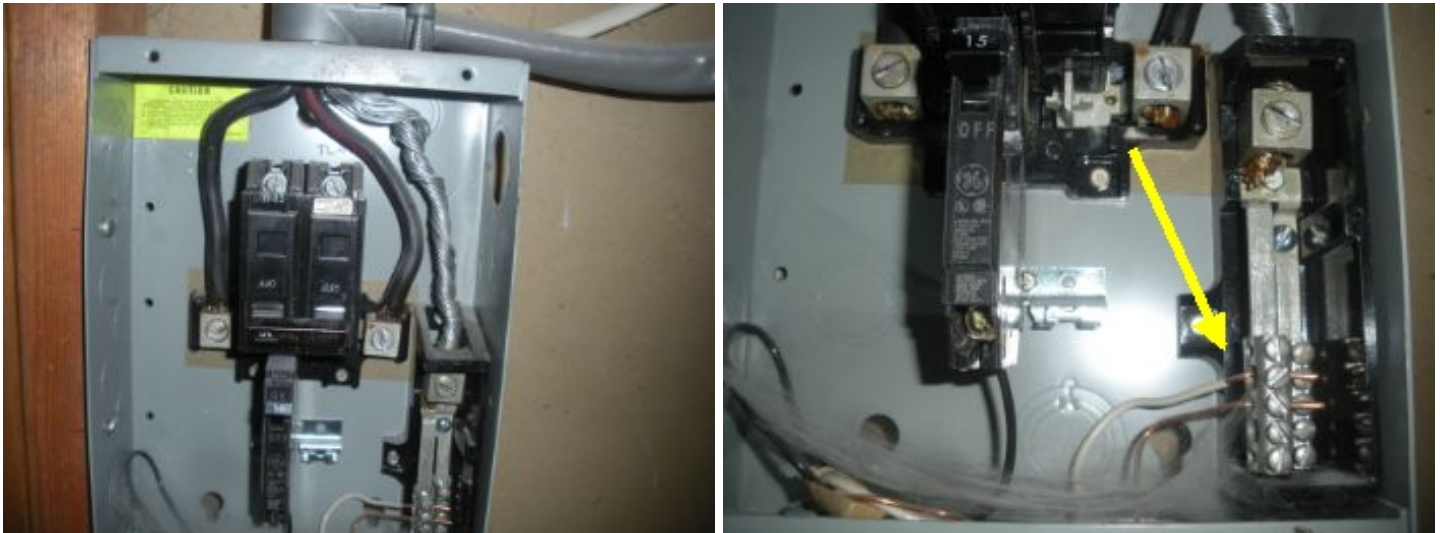
Needs Attention: There are improper connections between the white wires and buss bar and the grounding wires, in a sub panel these should connect to separate buss bars. These should only be interconnected at the main panel, and it creates a shock hazard and should be repaired by a qualified electrical contractor.

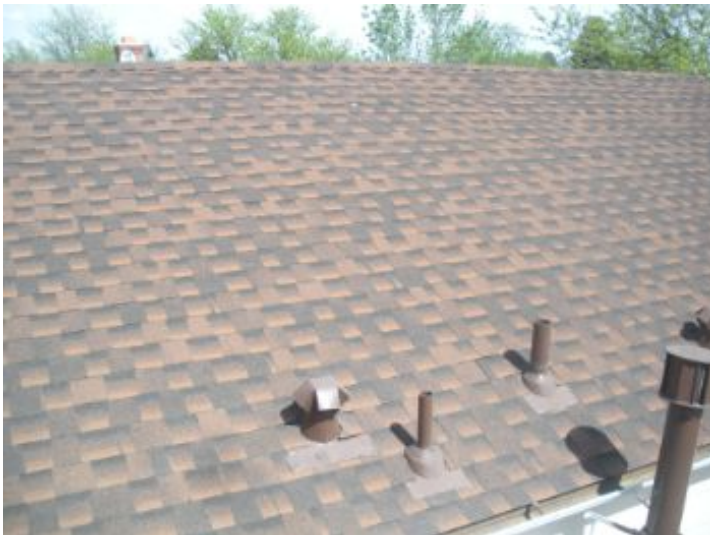
The roof appeared generally serviceable and within its expected life. (There is no claim to it's ability to exclude water, due to the many components that comprise a roof system that are not visible)

Left side of the house

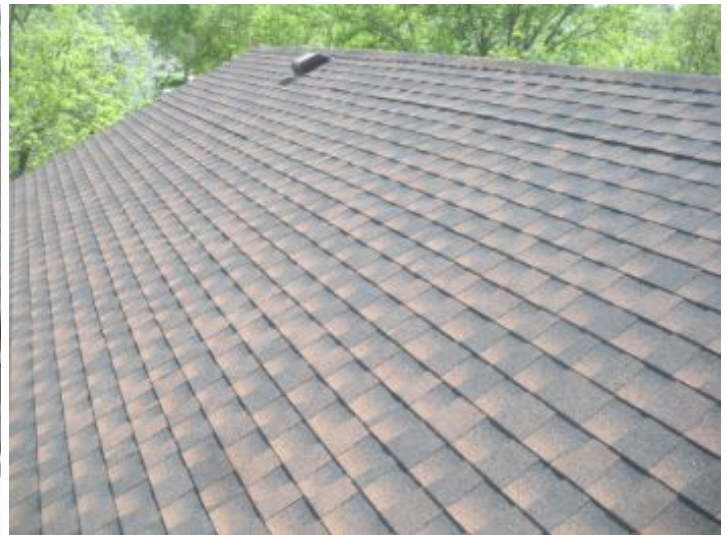
Right side of the house

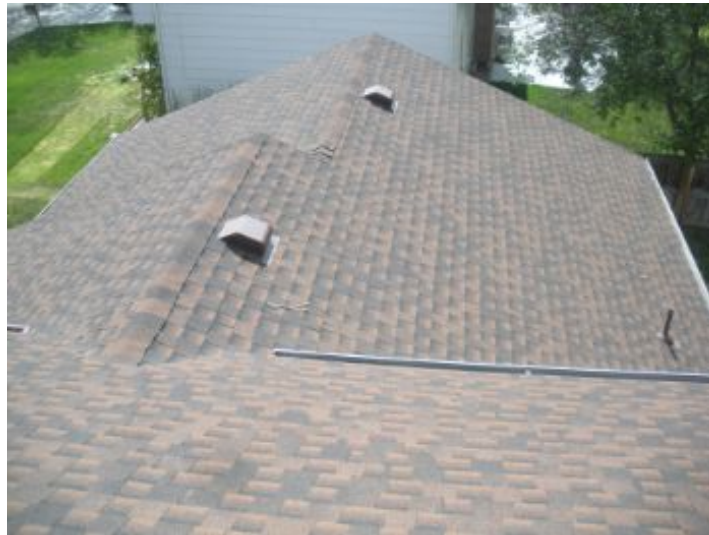
one story section

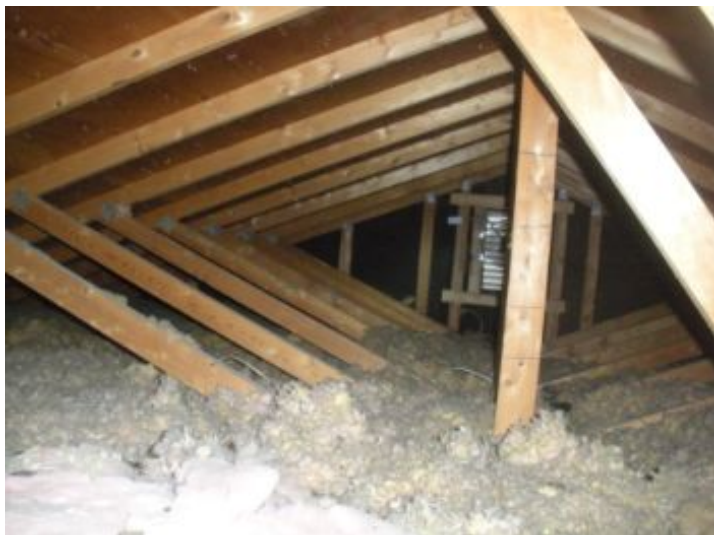
Lower Attic

Serviceable

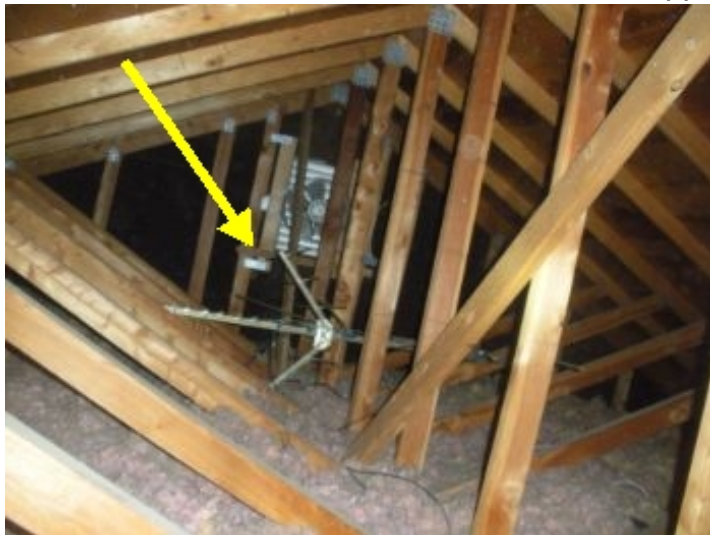
Antenna

TV antenna observed.

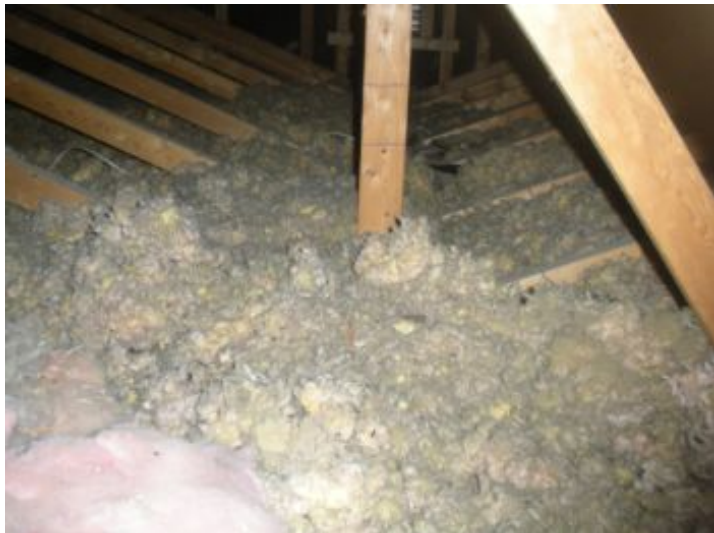
Lower Attic

Serviceable

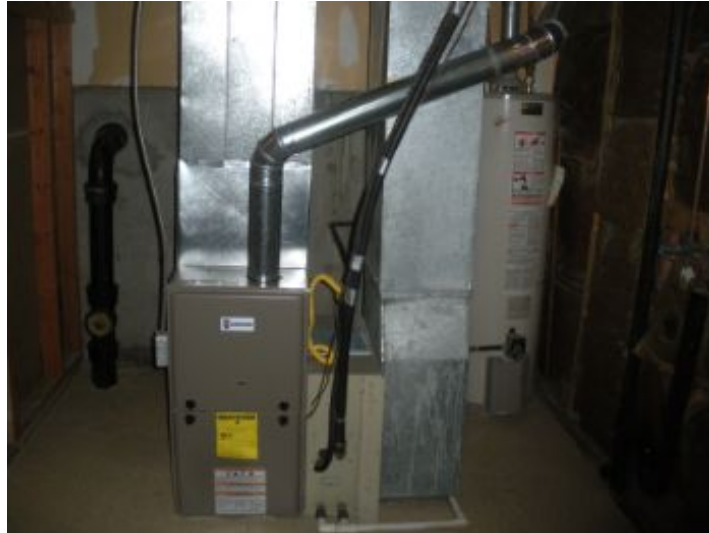
Serviceable

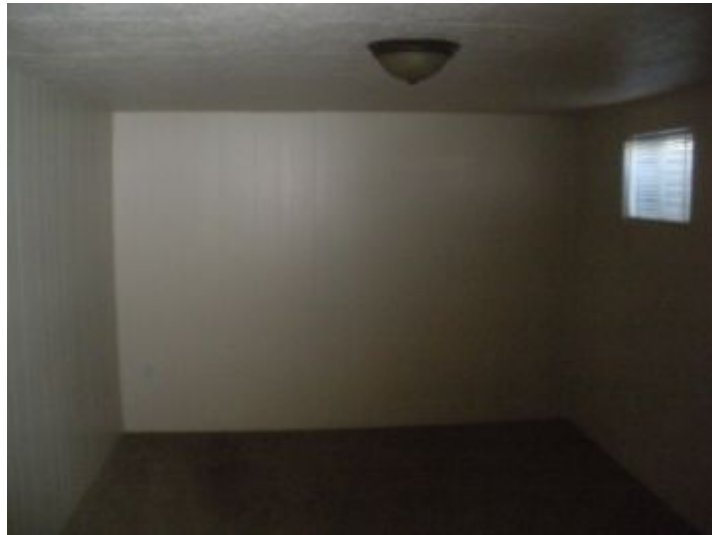
Basement Bedroom

Not Acceptable: There is no provision for heating in the basement's finished bedroom. A permanent source heat is a standard requirement for habitability.

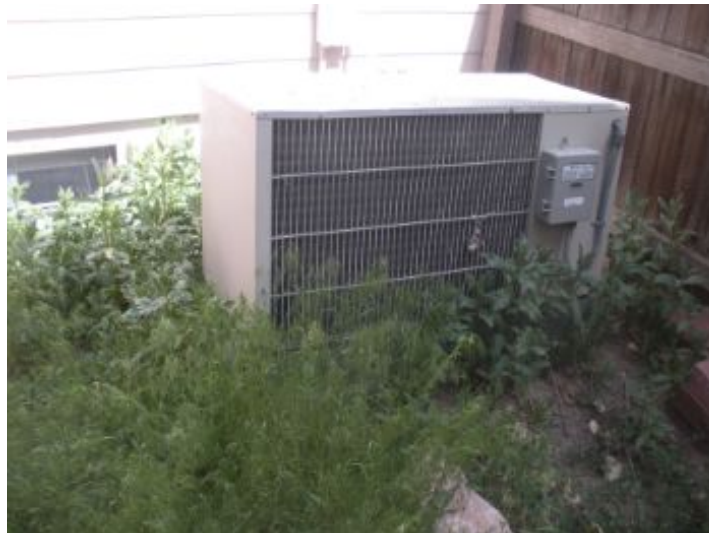
Needs Attention: There is soil and debris piling up around the condenser. This will cause it to be inefficient and rust and corroded over time.

Needs Attention: The refrigerant lines have damaged insulation on them. This will cause them to be inefficient and they should have the insulation repaired.

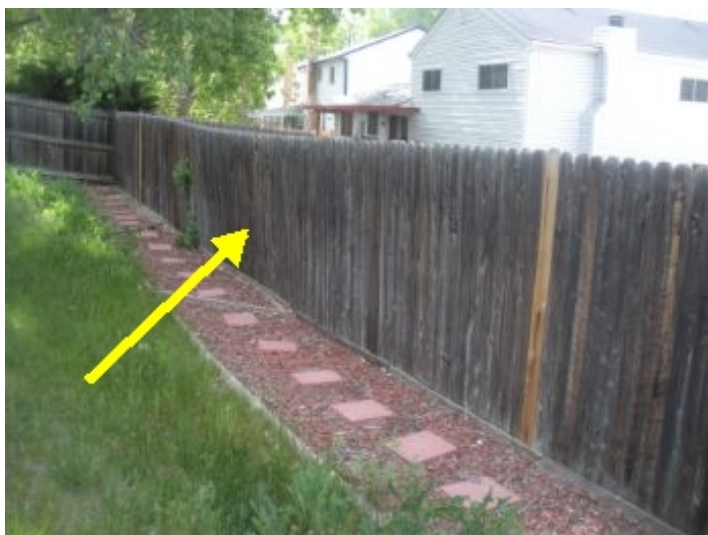
Needs Attention: There are loose and deteriorated posts on the fence. This is causing the fencing to lean or be wobbly in areas, such as the rear side.

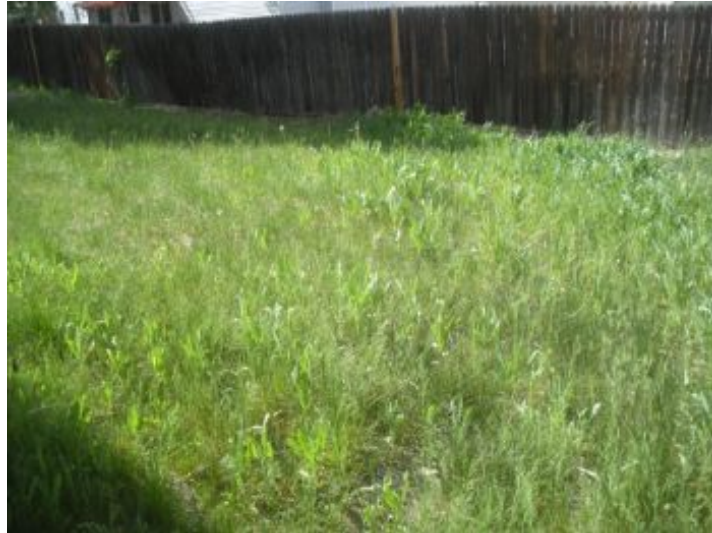
The grounds on the property are overgrown and neglected, and will need clean up and maintenance.

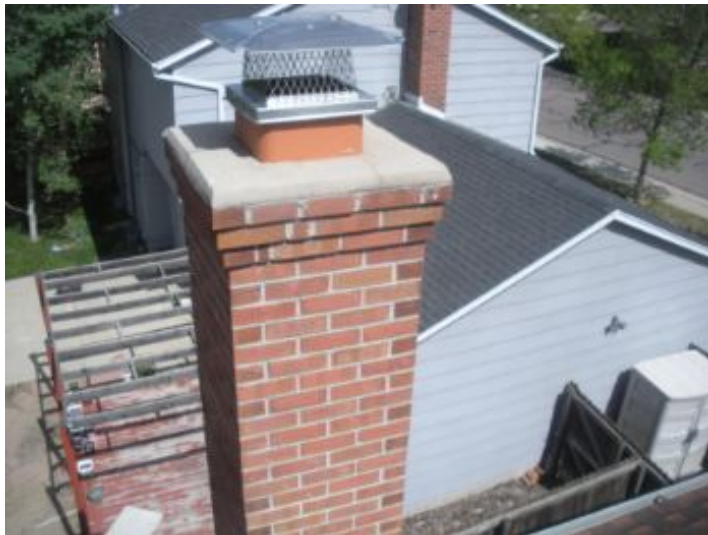
Serviceable: The portions of the chimney that are exposed / accessible / readily visible appear to be generally intact and functional, however most of the components of the chimney system are not visible or evaluated in this limited inspection. This is not an evaluation of its compliance with codes, the structural soundness of the system, or of it's ability to separate the hot combustion gasses from the house structure and avoid a building fire. It is beyond the scope of the inspection to determine the condition of the chimney as this requires observing the inside of the flue for cracks. This is usually done by a chimney expert using a video scope. It is advised to have this done at this time.

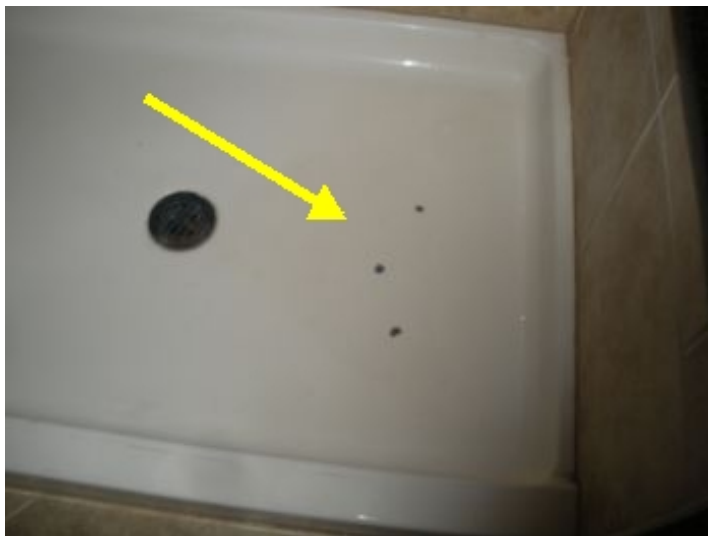
Needs Attention: The shower base has been painted/refinished, suggest taking care when cleaning to protect the surface.

Paint peeling
